# **Opalia Stage 2K**

# **GITA Inspection Verification Report**

| Prepared For: | Lojac Civil Pty Ltd | | |
|---|---|--|--|
| Report Number | D19221A V1 | | |

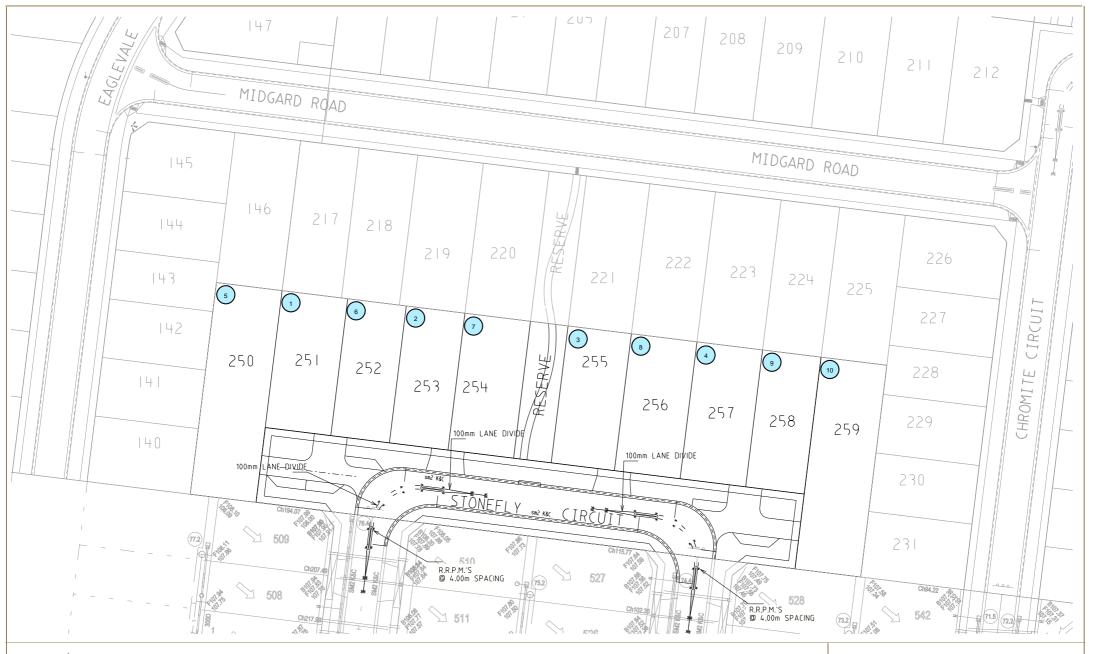
Test Location Plan
not to scale

Compaction Verification testing is summarized in a detailed test register with test certificates attached provided in Appendix 2: *Compaction Test Register and Test Certificates*. A test location plan (D19221D1, Appendix 1) providing a schematic of test locations across the extent of scope of works for every placed layer of fill is also documented.
