Opalia Estate Stage 8

GITA Inspection Verification Report

Prepared For: Lojac Civil Pty Ltd

Report Number D22760A V1

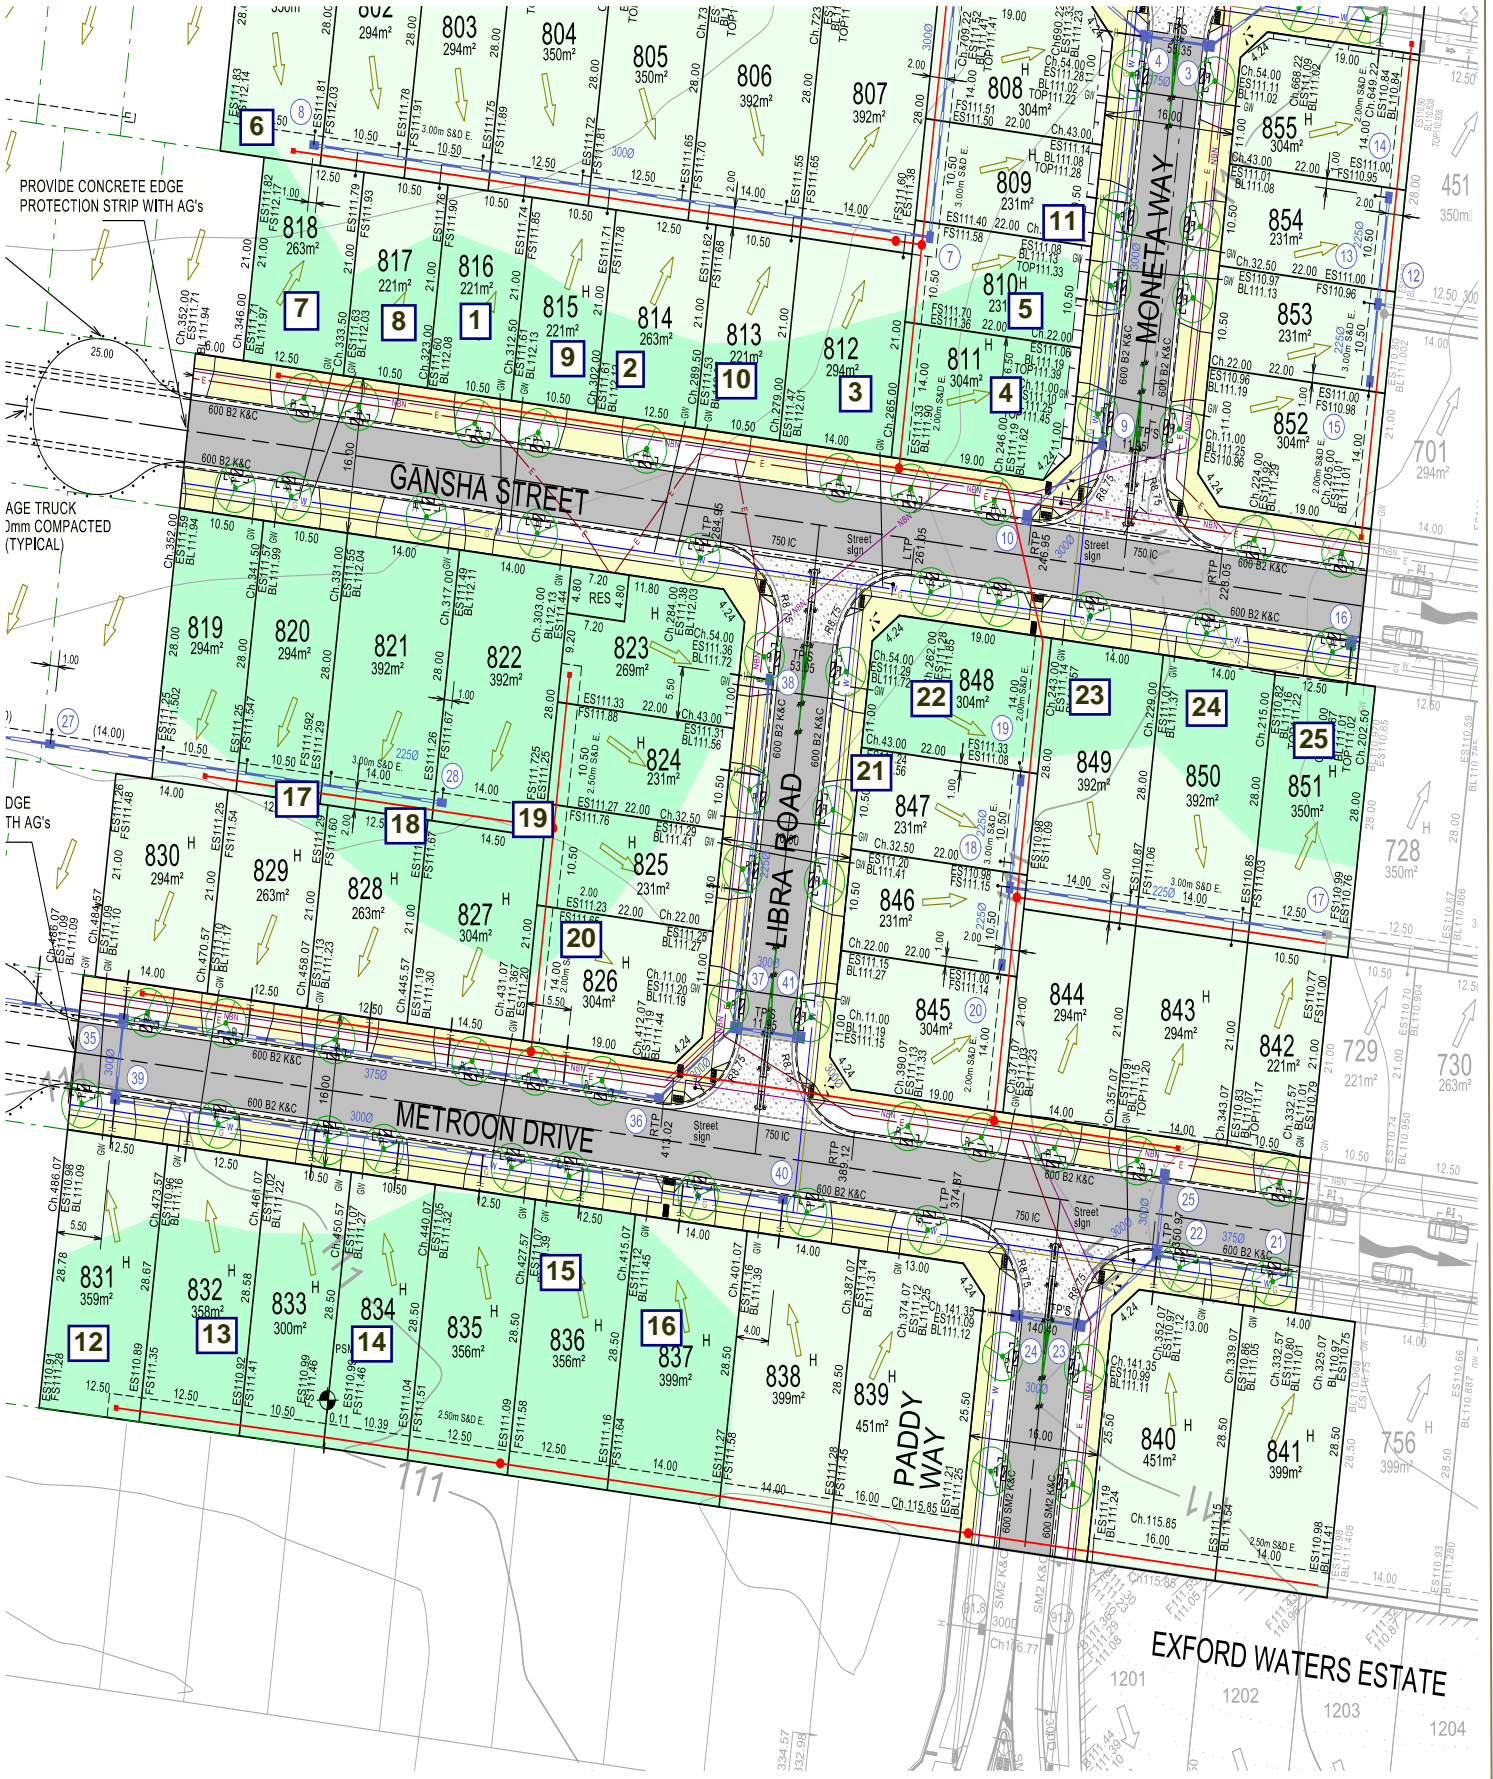
Test Location Plan
not to scale

plan (D22760D1, Appendix 1) providing a schematic of test locations across the extent of scope of works for every placed layer of fill is also documented.

A total of 25 density tests (Hilf method in accordance with 1289 5.7.1) were undertaken with 0 failed results. The results summarised in the compaction test register (Appendix 2) confirm that for every layer of fill placed in a specific work area, satisfactory testing was completed.
