Opalia Estate Stage 9A

GITA Inspection Verification Report

Prepared For: Lojac Civil Pty Ltd

Report Number D23978A V1

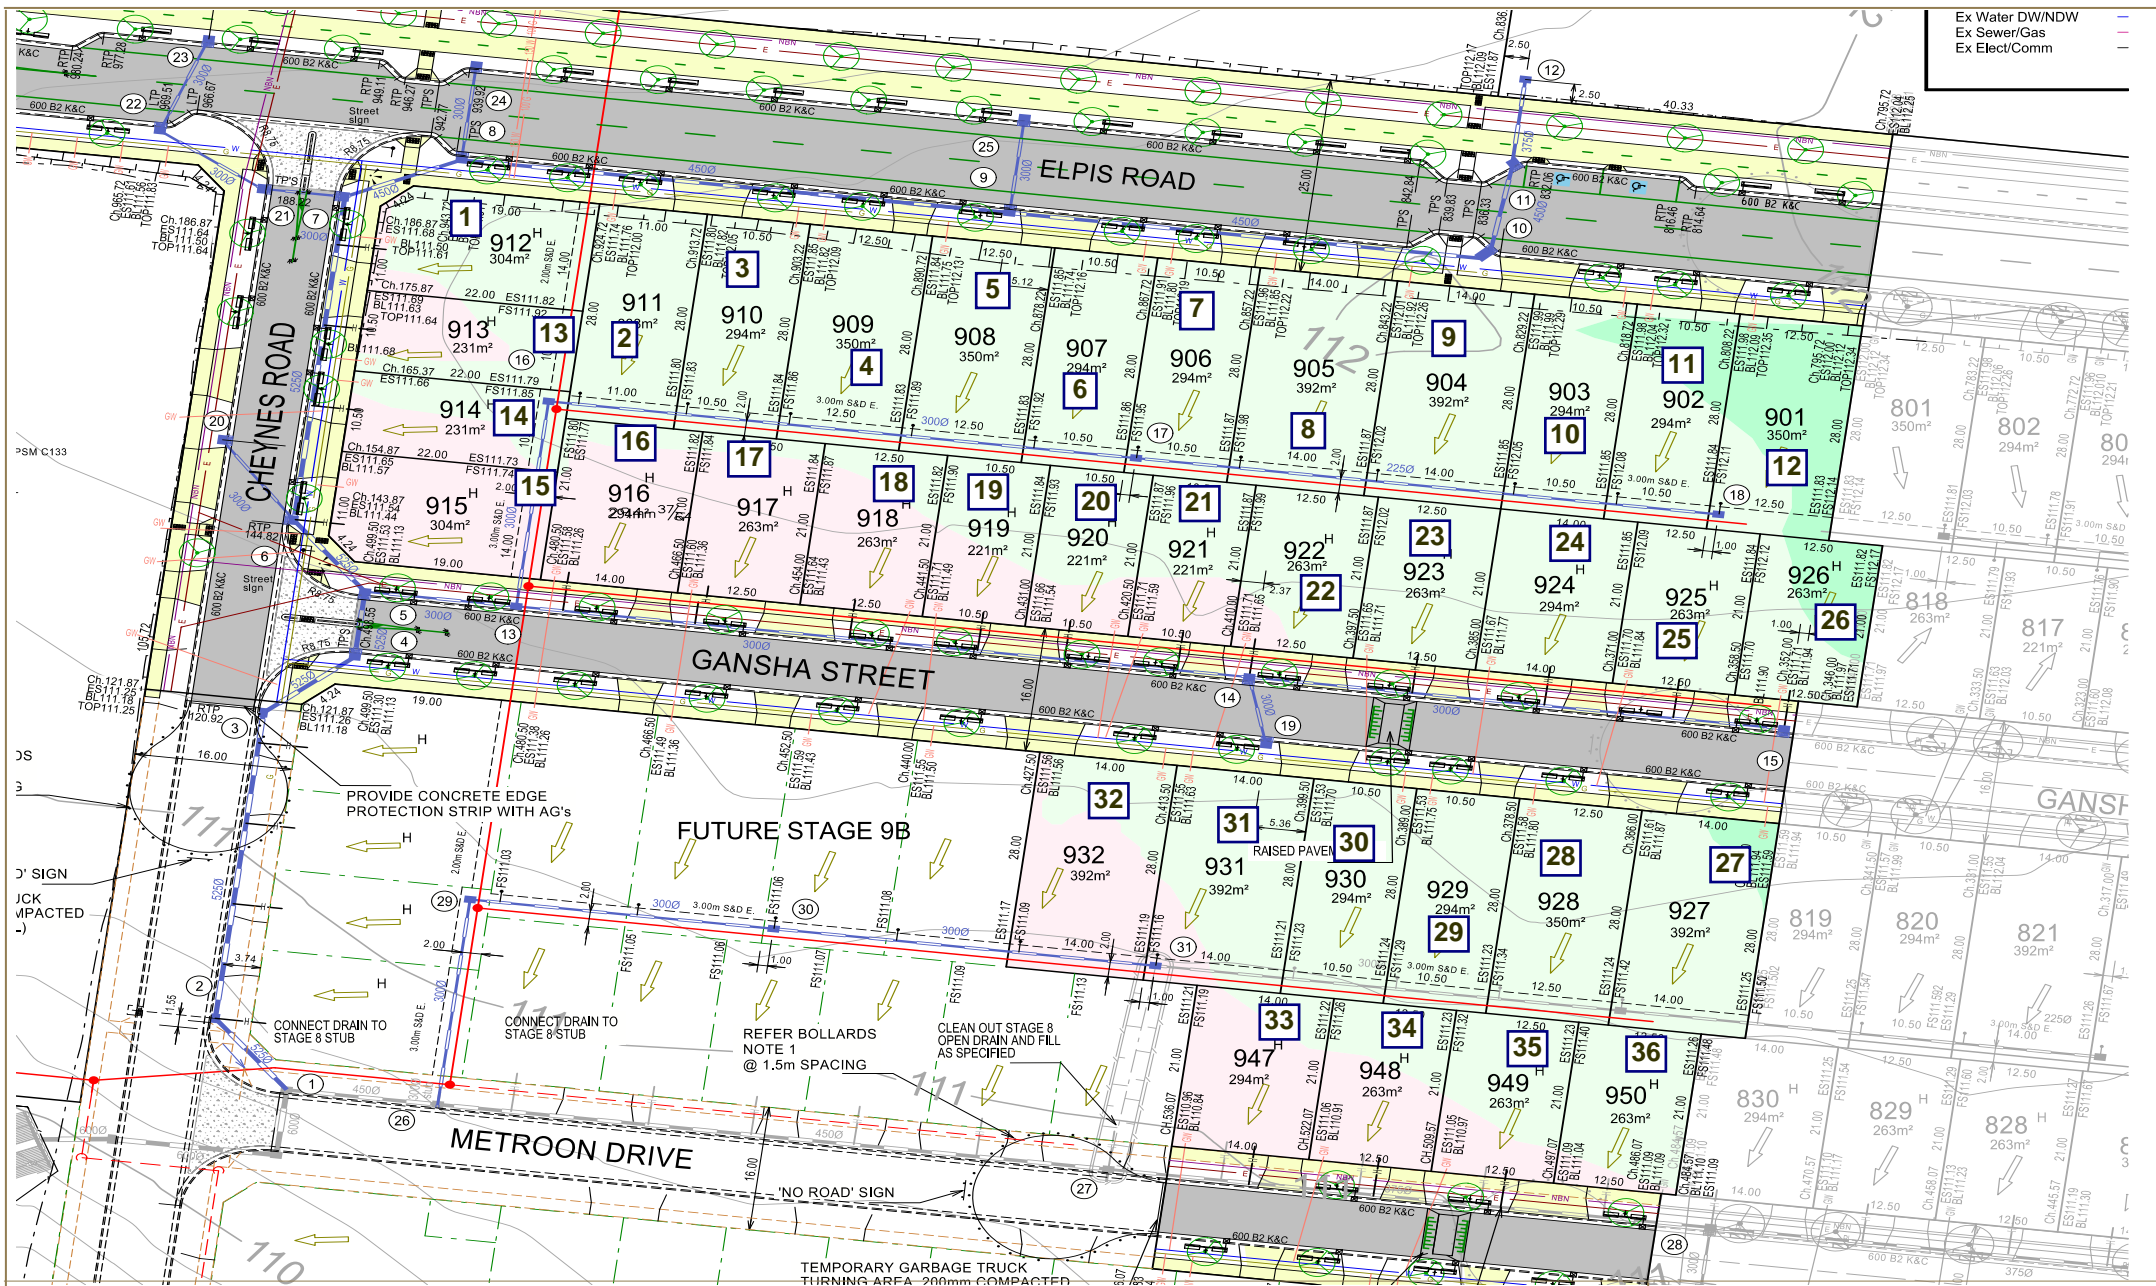
Test Location Plan
 not to scale

plan (D23978D1, Appendix 1) providing a schematic of test locations across the extent of scope of works for every placed layer of fill is also documented.
